# Avoiding Connector and Backplane Damage During CRU/FRU Replacement

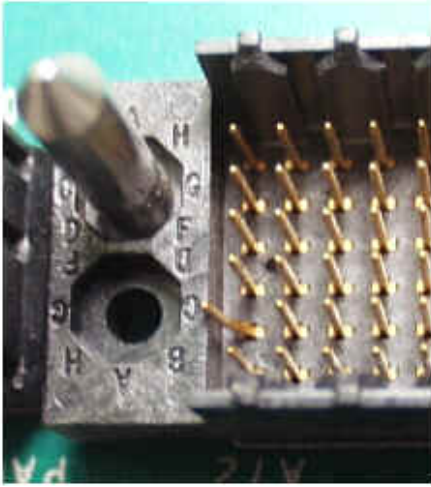
Initially, a bent pin might look like those shown in Figure 1 and Figure 3. After successive CRUs/FRUs have been installed in those slots, the bent pins can be crushed and look like those shown in Figure 2 and Figure 4.

If a bent pin is found, replace the backplane (or enclosure). Do not try to straighten the pins; they are easily deformed. Locate all CRUs/FRUs that have been installed in this slot and inspect their connectors as described in Step 2. To replace a backplane, you must be a trained service provider. See the backplane-replacement section of the NonStop S-Series Service Provider Supplement in the Hardware Service and Maintenance library.

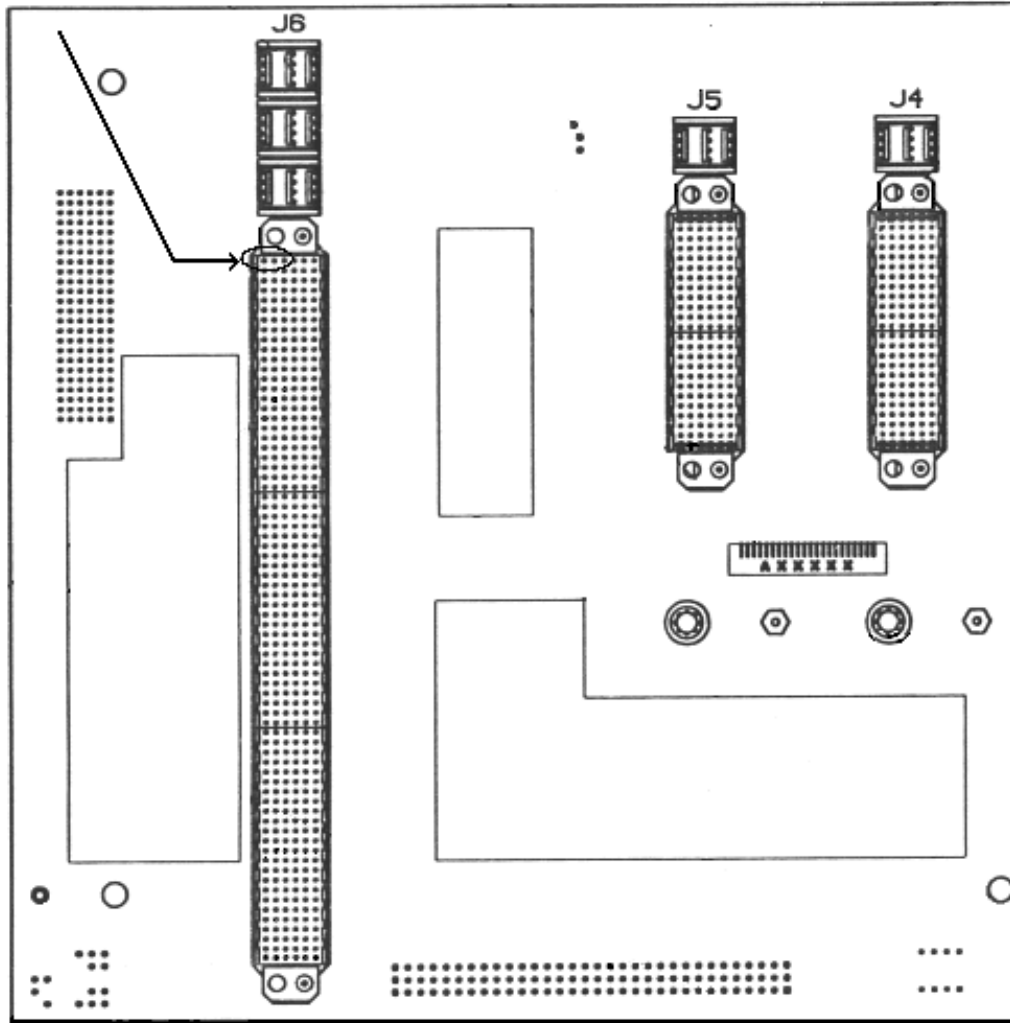
# Figure: PMF CRU and IOMF CRU Slots

Pay particular attention to the pins around the perimeter of the connector and to the top row of pins. In slots 50 and 55, the 3 left pins on the top row are the most susceptible to damage. See [PMF CRU and IOMF CRU Slots](#). When a PMF CRU or IOMF CRU is installed, these 3 pins are engaged by a section of the CRU connector that is more likely to propagate damage.

Three left pins on top row (slots 50 and 55)

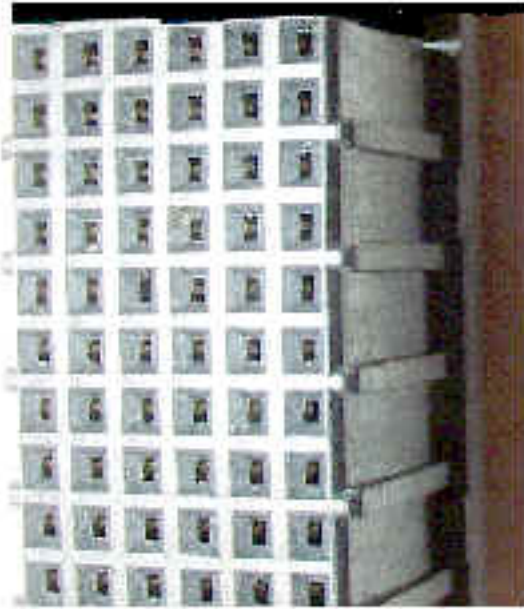
# Figure: Top Row Margins

Examine the perimeter of the shell for small notches, scrapes, and indentations. On PMF CRUs and IOMF CRUs, pay particular attention to the shell immediately above the 3 right sockets on the top row (facing the connector). This section of the shell is more susceptible to damage because the margins (distance) between the top of the shell and the socket windows are thinner here. See [Top Row Margins](#) and [Examples of CRU/FRU Connector Damage](#).

On CRU/FRU connectors, the plastic shell above the top row of sockets is thinner on the right half of the connector than on the left.

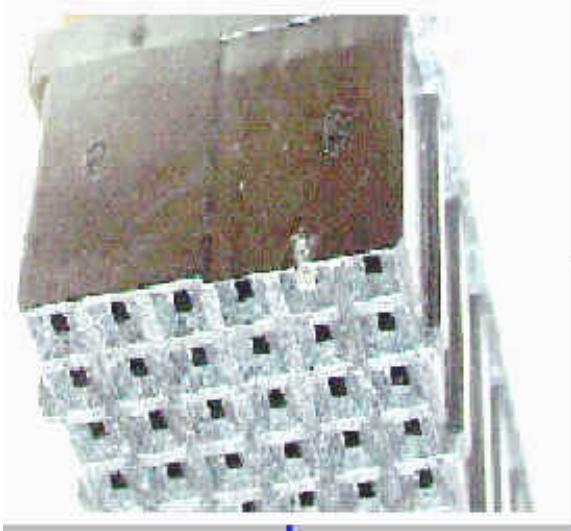
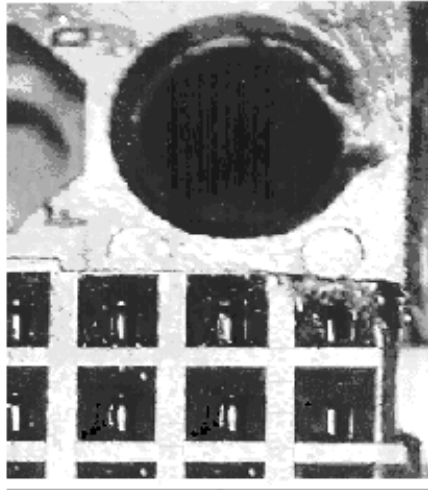
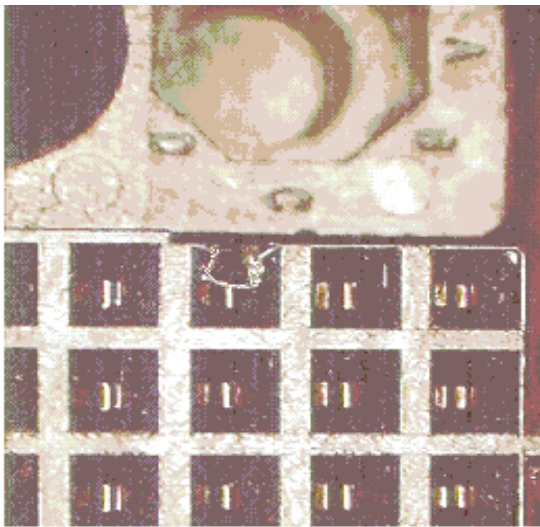
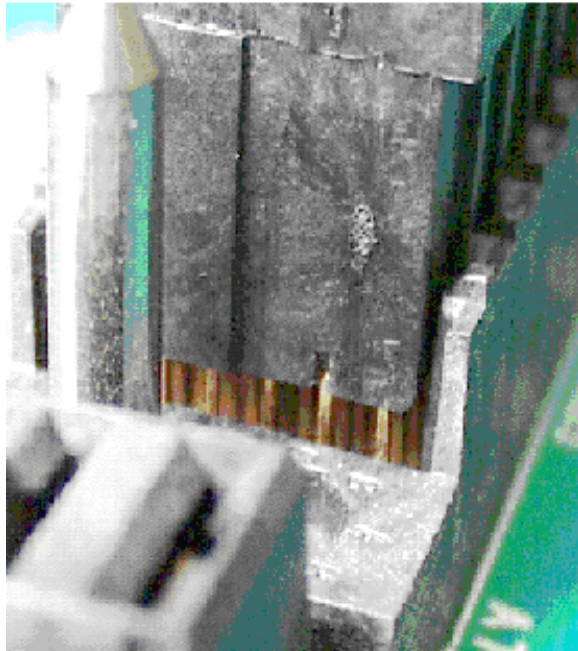
# Examples of CRU/FRU Connector Damage

Check the sockets for damage. On PMF CRUs and IOMF CRUs, pay particular attention to the 3 right sockets on the top row, where damage most commonly occurs. Check the windows for punctures, deformations, and obstructions. See [Examples of CRU/FRU Connector Damage](#).

If any damage is found, replace the CRU/FRU. Locate all slots where the unit has been installed and inspect those backplane connectors as described in Step 1. Describe the damage and its location in Genesis and on the Part Return Tag (PRT).

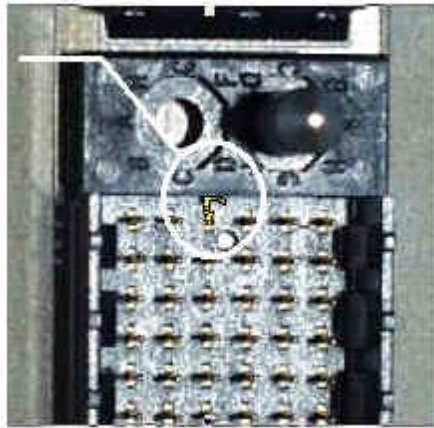
**Figure 1**

Figure 1 shows a pin crushed against the wall of a backplane connector. When a good CRU/FRU is installed in this slot, the damaged pin will cut a notch in the edge of the CRU/FRU connector (Figure 2). If that CRU/FRU is then plugged in to a good slot, the notched connector will bend a pin in that slot (Figure 3). Figure 4 shows the bent pin. When a good CRU/FRU is then installed in this slot, the bent pin can be crushed to look like Figure 1 and the cycle of damage continues.

Crushed backplane pin, ready to damage connector shell of next CRU/FRU plugged into slot.

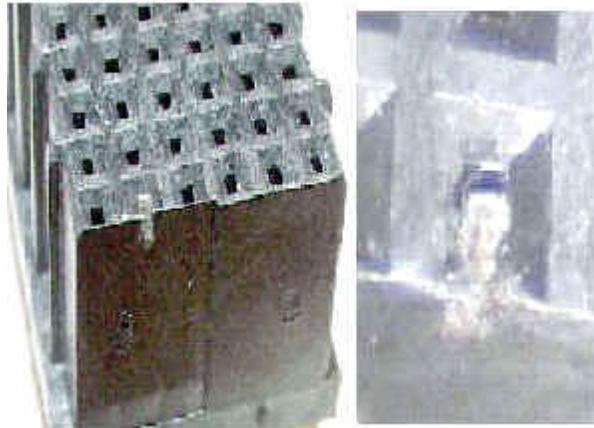
**Figure 2**

Notched CRU/FRU connector after unit is plugged in to a slot with bent pin. (Note: pin aperture is blocked; window ramp is deformed.)

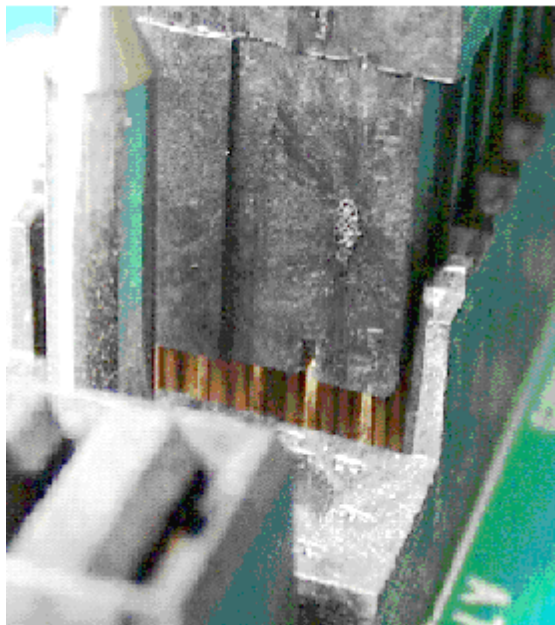
**Figure 3**

Pin in good slot being bent by seating a CRU/FRU with a damaged connector.

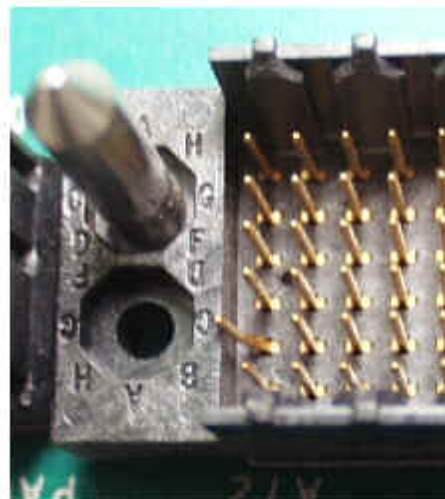
**Figure 4**

Bent pin in slot, ready to damage connector shell of next CRU/FRU plugged in to slot.

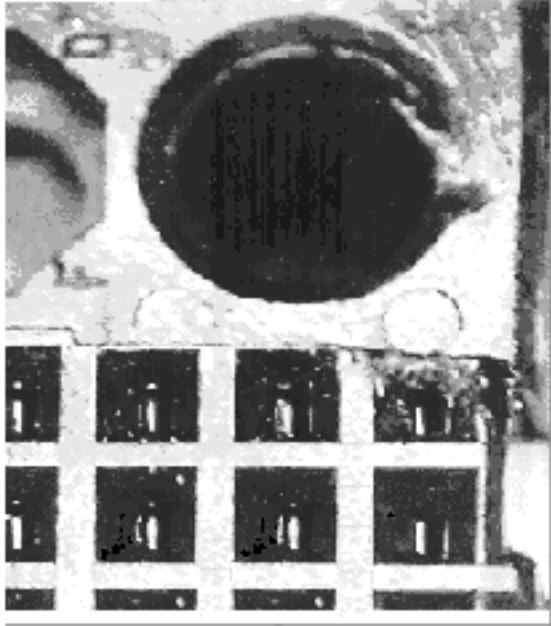
# Figure: Damage Due to Handling

Bumping a CRU/FRU's connector against a surface can cause aperture damage to the connector. This type of damage will bend pins on the backplane and thus propagate damage.

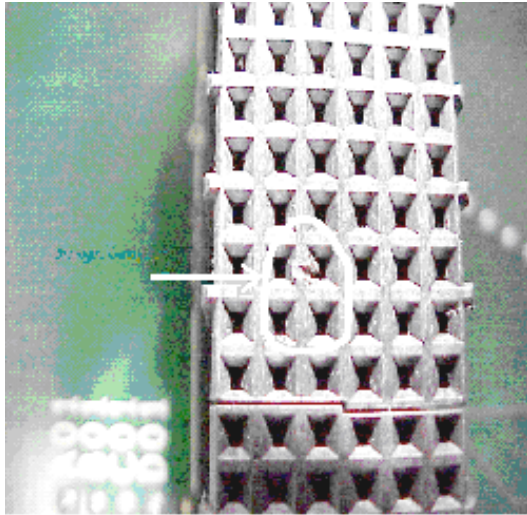
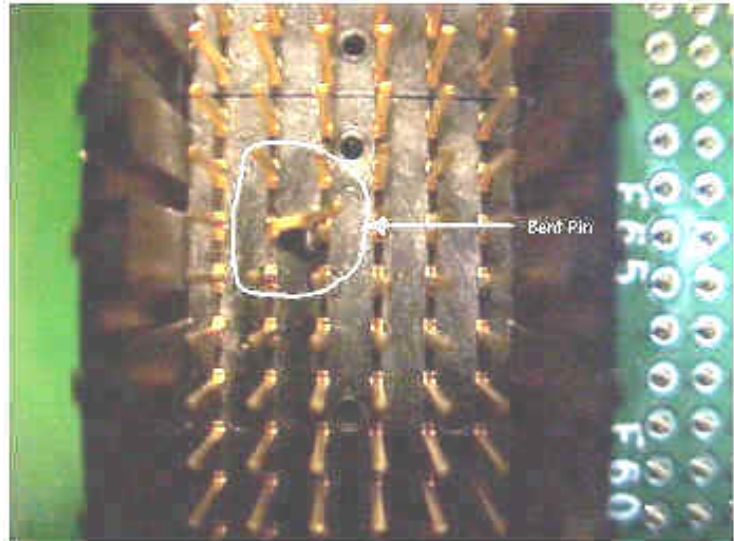
Figure 1 and Figure 2 show damage that will be propagated. Figure 3 shows the crushed pin that caused the imprint on the CRU/FRU connector shown in Figure 4. This imprint is not likely to damage other backplane connectors, because the mating pin's path is not affected. This backplane and CRU/FRU should still be replaced. (For an enlargement of the crushed pin shown in Figure 3, see Figure 4 in [Examples of Damaged Pins on Backplanes](#).)

Damage that will be propagated.

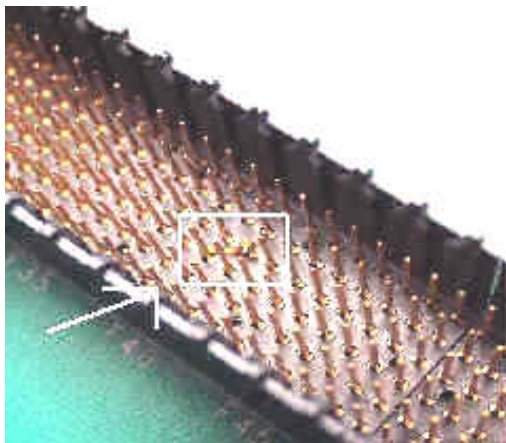
**Figure 3**

Crushed pin that caused imprint in Figure 4.

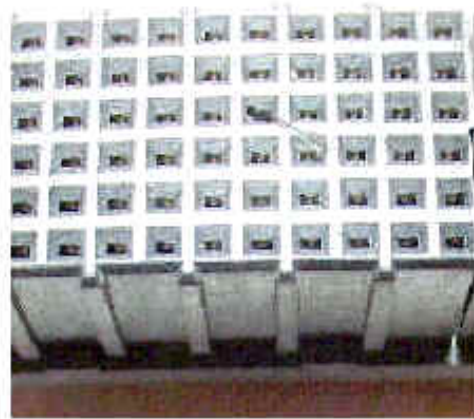
**Figure 4**

Imprint that might not propagate damage.
